UNITED STATES ENVIRONMENTAL PROTECTION AGENCY

MEMORANDUM

SUBJECT: ON-SCENE COORDINATOR'S REPORT - Removal Action at the Columbus Auto Parts Site, Columbus, Franklin County, Ohio (Site ID #XR)

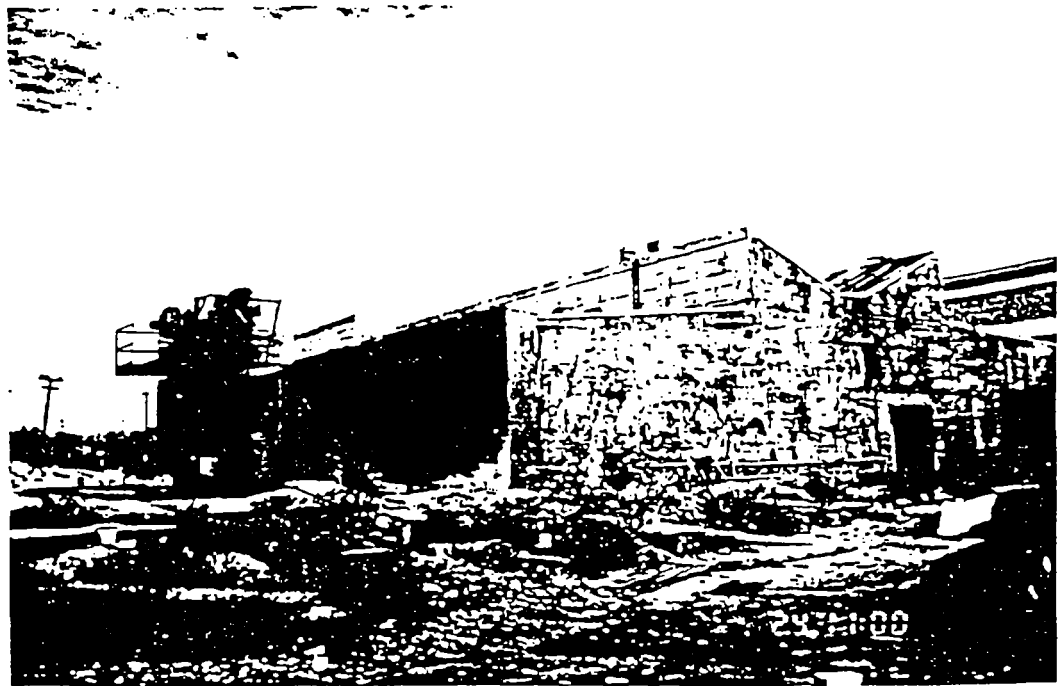
SITE: Columbus Auto Parts TDD: S05-9601-041 PAN: 6J4101RAAO PHOTO: 10
 DIRECTION: Northeast DATE: 10/24/94 PHOTOGRAPHER: Spangler
 DESCRIPTION: Overview of the southwest corner of building 1A. The area where the USTs were buried is located in the left foreground.

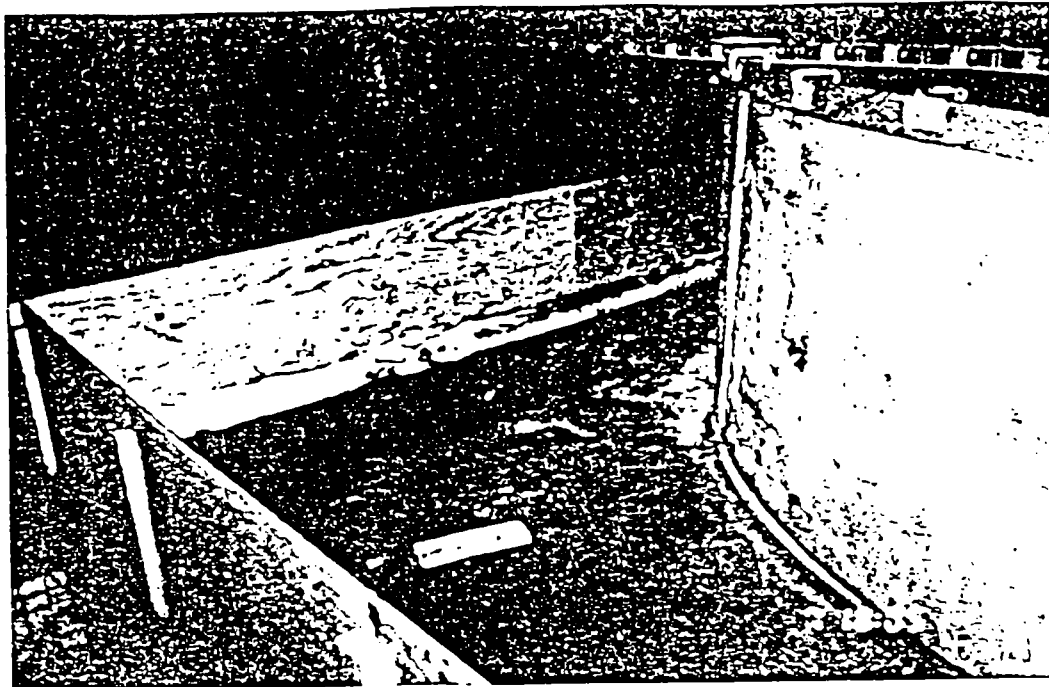
SITE: Columbus Auto Parts TDD: S05-9601-041 PAN: 6J4101RAAO PHOTO: 2
 DIRECTION: Southeast DATE: 11/07/94 PHOTOGRAPHER: Spangler
 DESCRIPTION: Wooden dike and sorbent boom placed around the swimming pool used for bulking oily wastewaters.

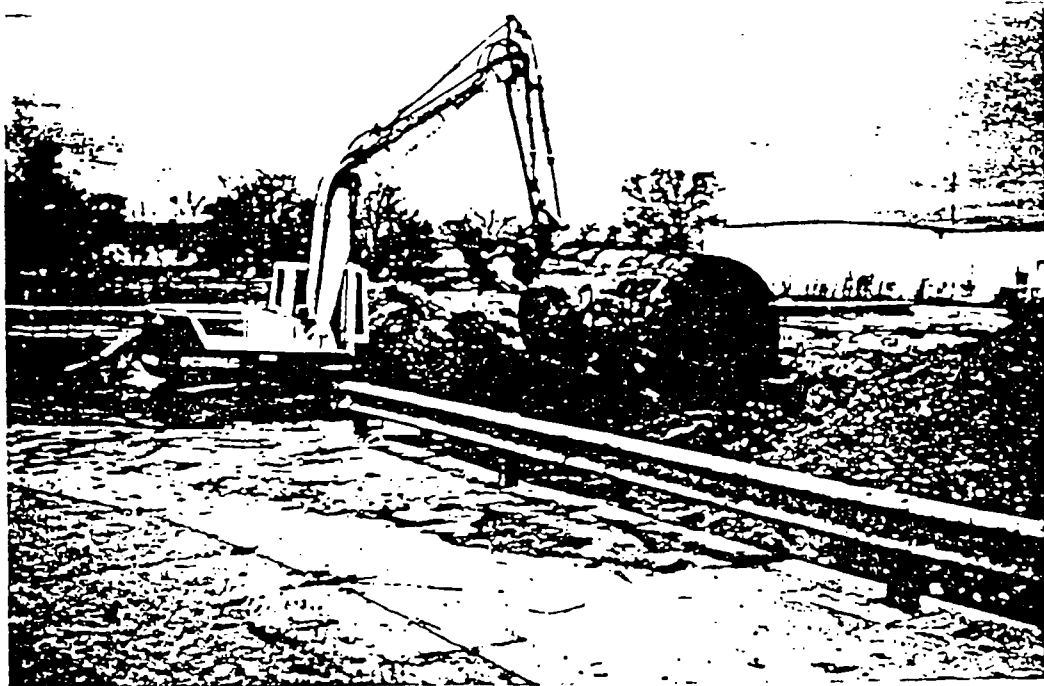
SITE: Columbus Auto Parts TDD: S05-9601-041 PAN: 6J4101RAAO PHOTO: 3
 DIRECTION: Northwest DATE: 11/03/94 PHOTOGRAPHER: Spangler
 DESCRIPTION: ERCS personnel removing one of the underground storage tanks.

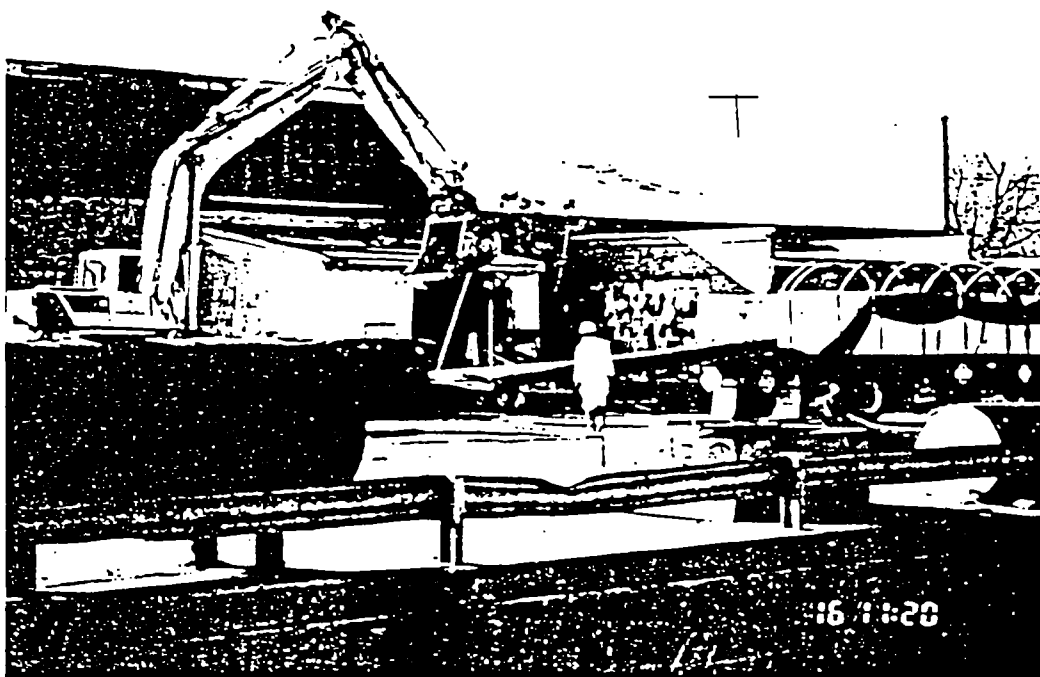
SITE: Columbus Auto Parts TDD: S05-9601-041 PAN: 6J4101RAAO PHOTO: 36
 DIRECTION: Southwest DATE: 11/16/94 PHOTOGRAPHER: Spangler
 DESCRIPTION: ERCS personnel loading the USTs for transportation to the landfill for disposal.

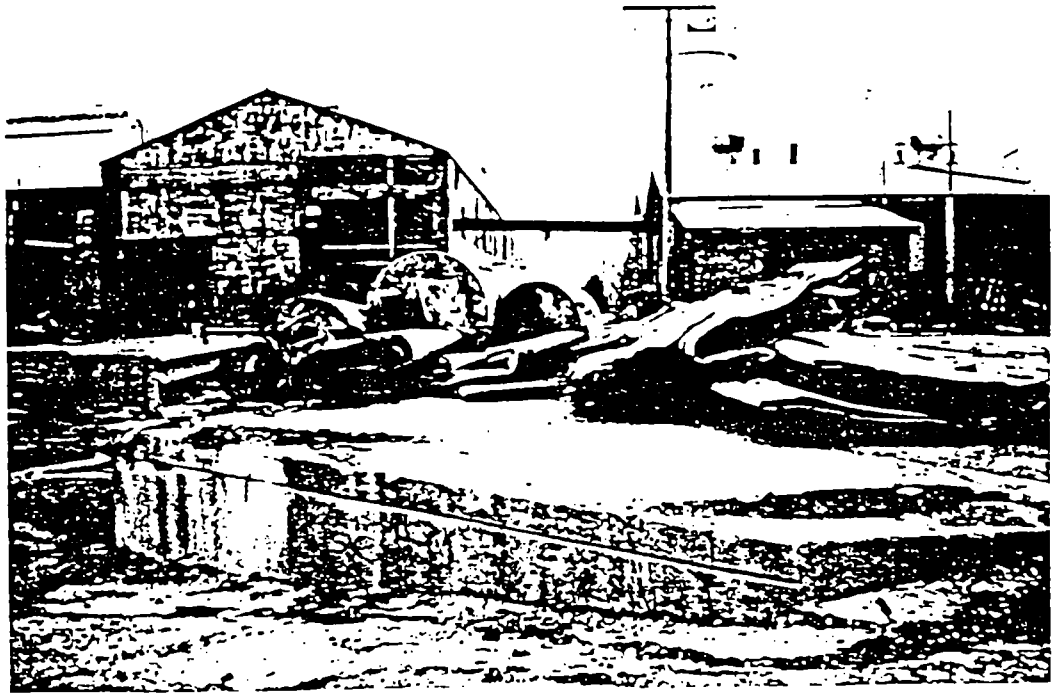
SITE: Columbus Auto Parts TDD: S05-9601-041 PAN: 6J4101RAAO PHOTO: 37
 DIRECTION: East DATE: 11/16/94 PHOTOGRAPHER: Spangler
 DESCRIPTION: Crushed USTs awaiting transportation and off-site disposal and remaining USTs awaiting transportation to smelting facility.

Two of the tanks were lined with a rubber-like material which was bonded to the structure of the tank itself, preventing its removal. As a result, these two tanks were crushed to the smallest size possible and were transported off site for disposal at a local landfill. The remaining tanks were steel and were recyclable. Arrangements were made to have the tanks smelted at LTV Steel in Cleveland, Ohio. This facility was chosen for disposal of the tanks because the tanks were delivered to the facility and immediately smelted. Other facilities could not guarantee how long the tanks would sit at their facility prior to being smelted.

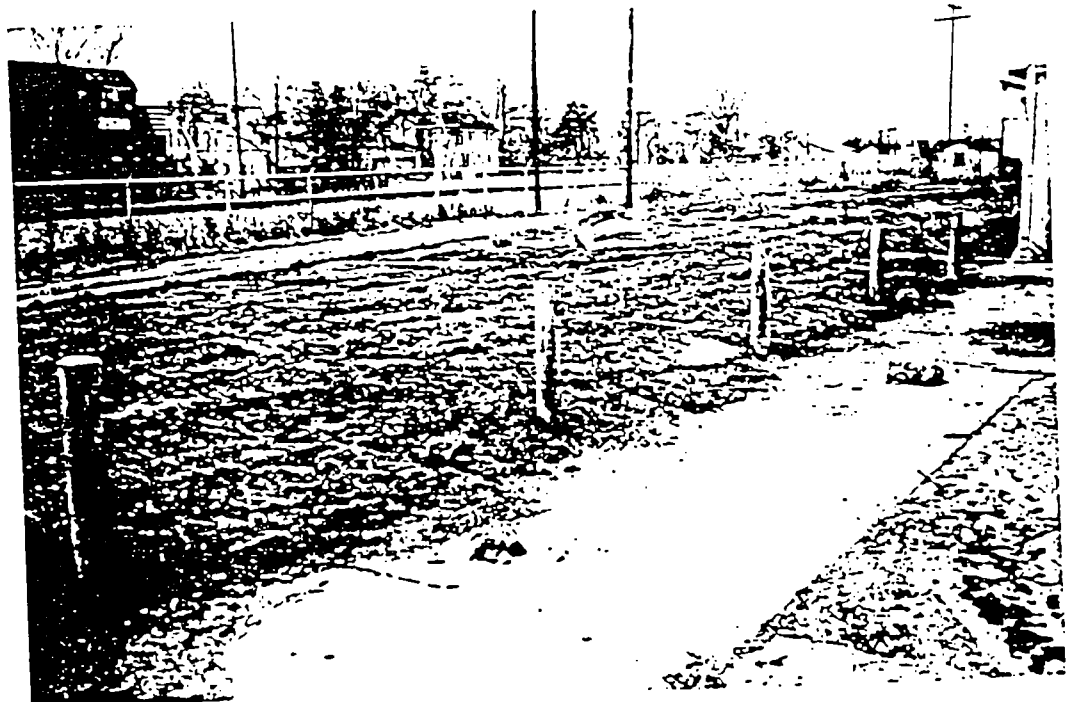
SITE: Columbus Auto Parts TDD: S05-9601-041 PAN: 6J4101RAAO PHOTO: 45
 DIRECTION: South DATE: 12/16/94 PHOTOGRAPHER: Spangler
 DESCRIPTION: Borrow area for clean soil to place over the loading docks to fill them to grade.

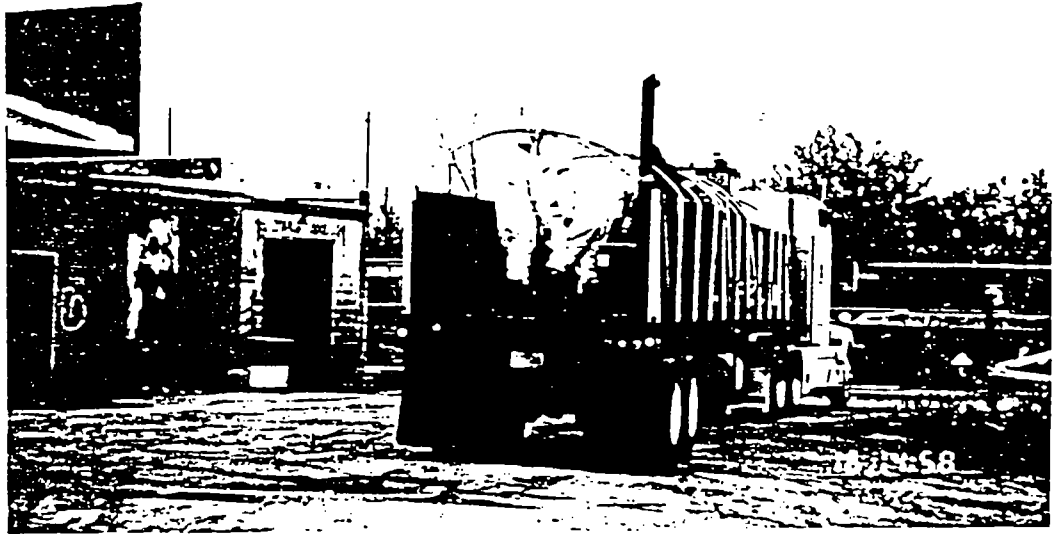
TE: Columbus Auto Parts TDD: S05-9601-041 PAN: 6J4101RAAO PHOTO: 48
 RECTION: Northwest DATE: 11/09/94 PHOTOGRAPHER: Spangler
 DESCRIPTION: ERCS personnel removing PCB transformer.

On October 31, 1994, a representative from OEPA familiar with the recognition and identification of PCB-containing electrical equipment, completed a site reconnaissance with the U.S. EPA OSC to identify PCB-containing equipment on site. A number of PCB-containing capacitors, as well as one transformer, were observed within the facility. In addition, a number of fluorescent lights equipped with PCB-containing light ballasts were observed on the site. ERCS personnel completed removal of the PCB capacitors on November 4, 1994, and removed the PCB transformer on November 9, 1994. The light ballasts were removed on November 17 and 18, as well as December 6, 1994. A total of 337 PCB light ballasts were removed and placed into drums for disposal.

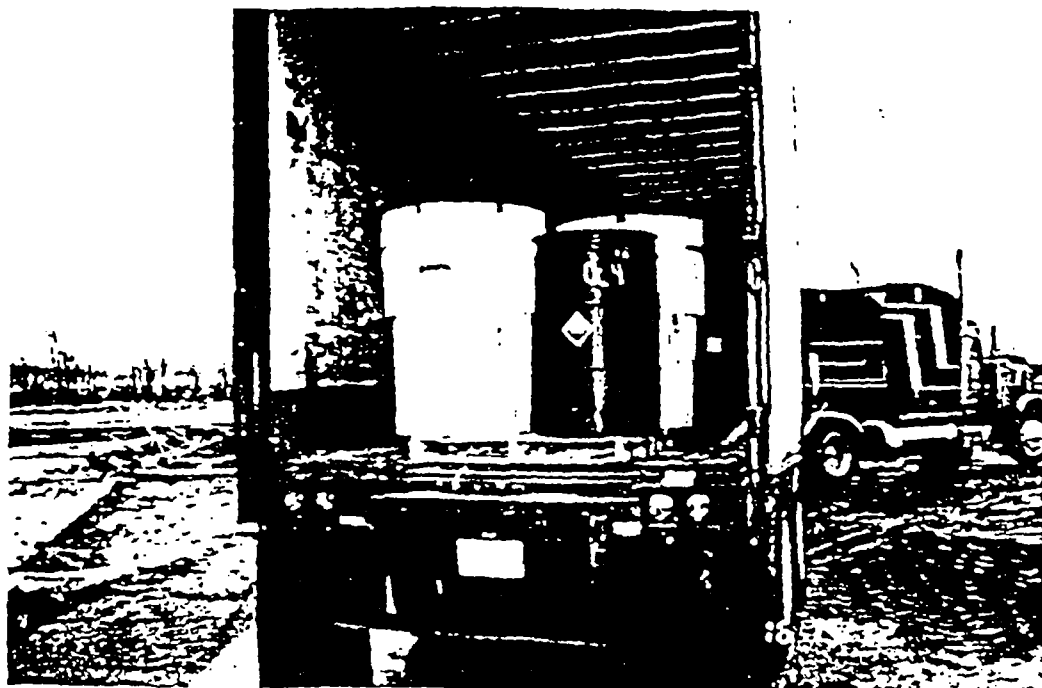
SITE: Columbus Auto Parts TDD: S05-9601-041 PAN: 6J4101RAAO PHOTO: 56
 DIRECTION: North DATE: 11/30/94 PHOTOGRAPHER: Spangler
 DESCRIPTION: Loading crushed drums and debris into rolloff box for transportation and off site disposal.
